Q. C. Marine Surveyors

Small Craft Condition & Valuation Survey

Date : 11/25/2019

Report Number: 102-11252019

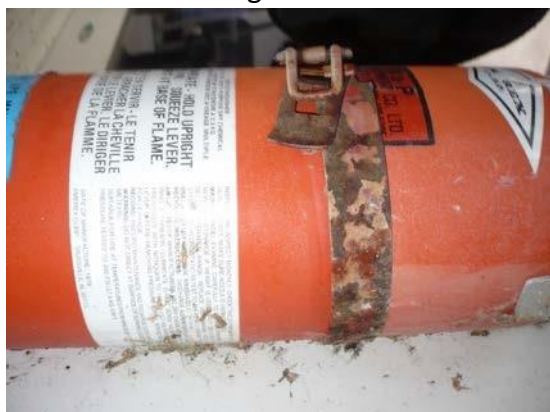
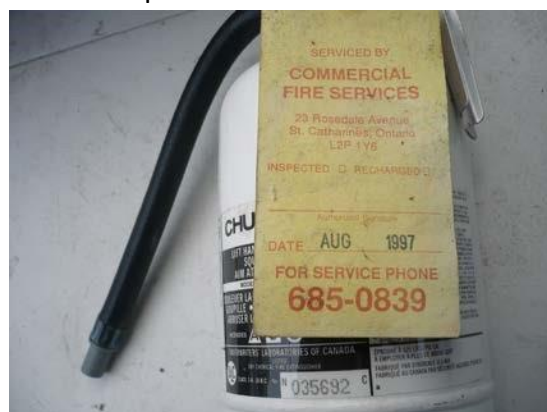
'A' 2 Fire extinguishers found are outdated and should be replaced

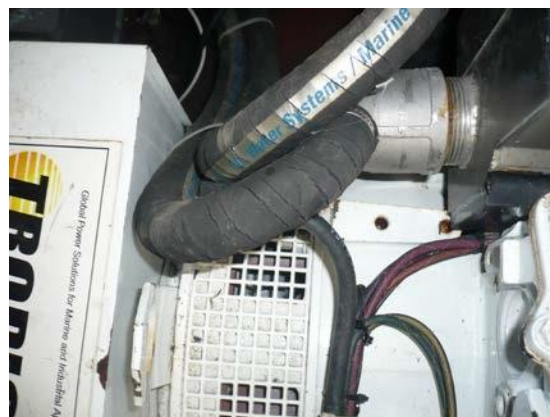
'B' Exhaust hose on generator cracked, should be replaced

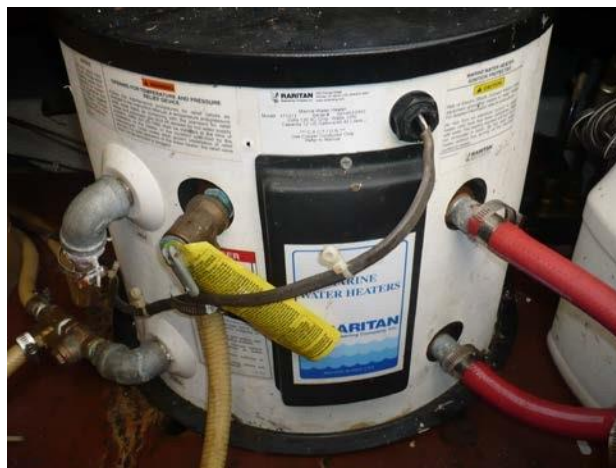
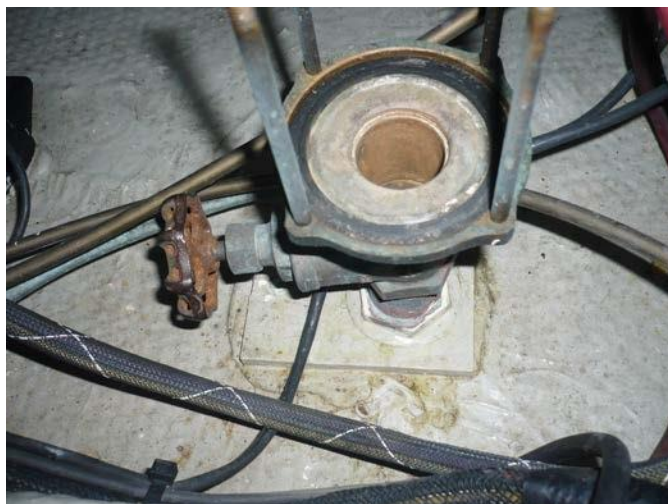
- ' B ' Hot water tank electrical wire strain relief not installed properly
- ' B ' Some electrical wire in engine and battery compartments found hanging down or laying in bilge, should be clipped up.
- ' C ' Positive terminals on batteries should be protected
- ' C ' Gate valve for main engine water intake should be replaced with marine grade ball valve.
