Q. C. Marine Surveyors

Small Craft Condition & Valuation Survey

Report Number: 001- 02042019

Name of Vessel: **Fidelia**

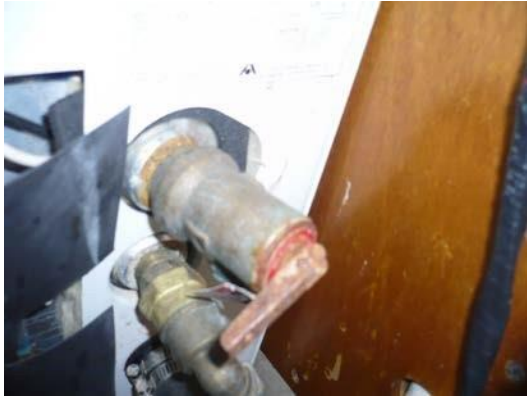
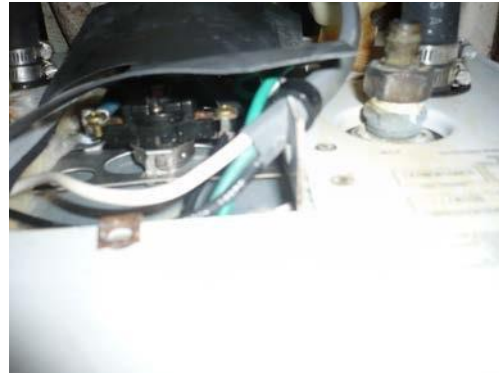
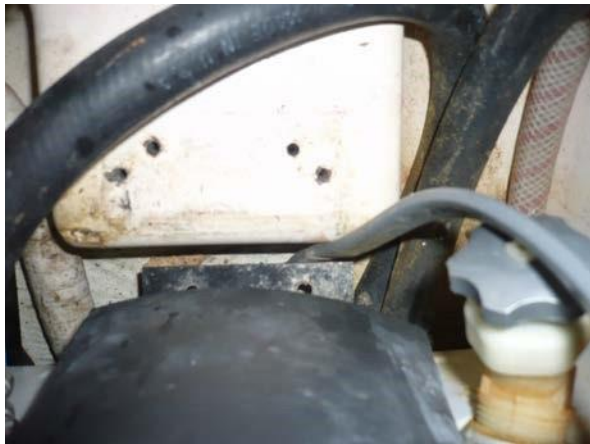
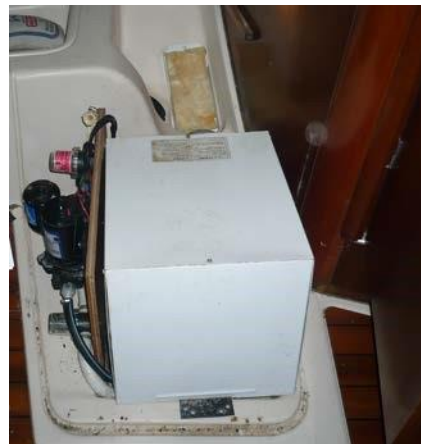
B - Hot water heater under starboard settee, pressure relief valve is corroded and sticking, requires service. The 110 VAC wire should have proper strain relief where the wire enters the unit, and the cable is being pinched by the base. The back panel should be installed properly. The entire unit appears to not be fastened properly to the floor, and the cover should also be fastened properly.

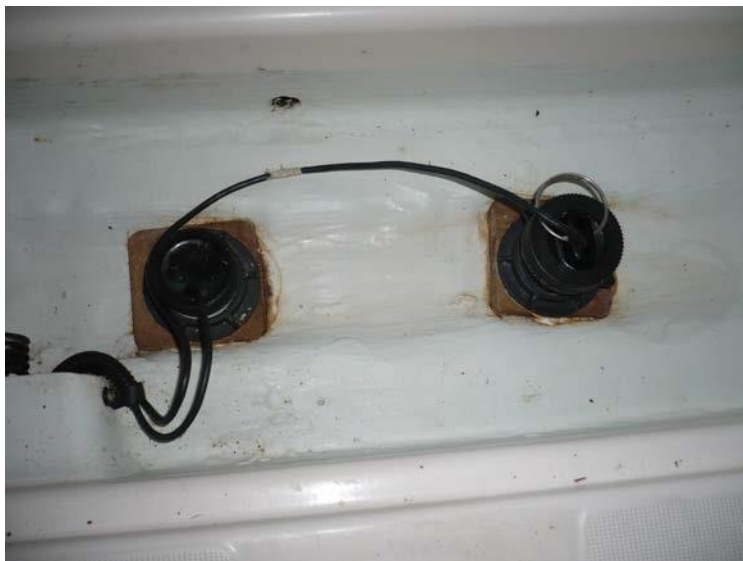
B - Speed and depth transducers should have fibreglass backing plates.

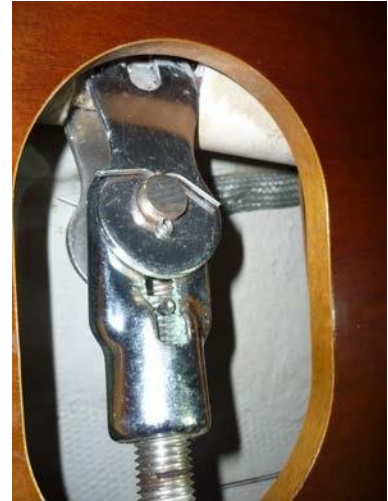
B - Higher moisture readings were found around the shroud bases on both port and starboard, indicating the beginnings of leaking in these areas. The port turnbuckle in the cabin is showing some indications of moisture on it. Recommend resealing these areas before the condition worsens. Also the cockpit floor section immediately aft of the binnacle is also showing higher moisture readings, that require investigation.

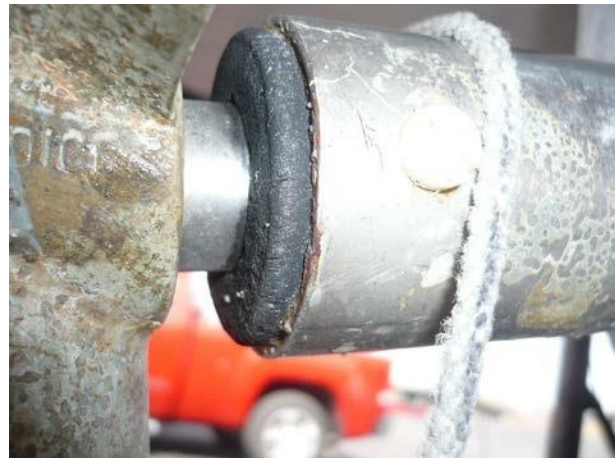
B - The propeller shaft tube seal/ bushing is dry and cracking indicating it may require replacement in the future.

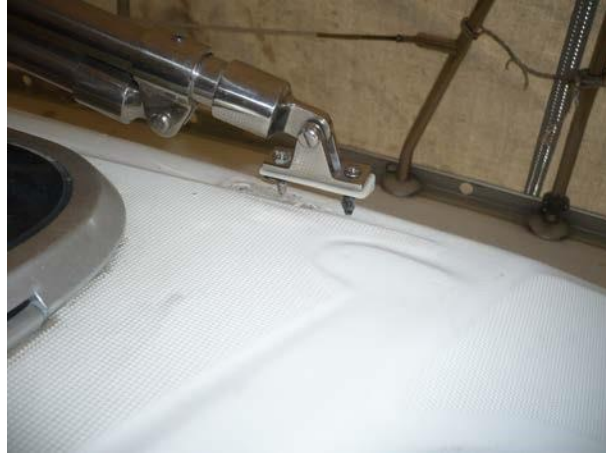
B - The base of the dodger frame on starboard side is not attached.

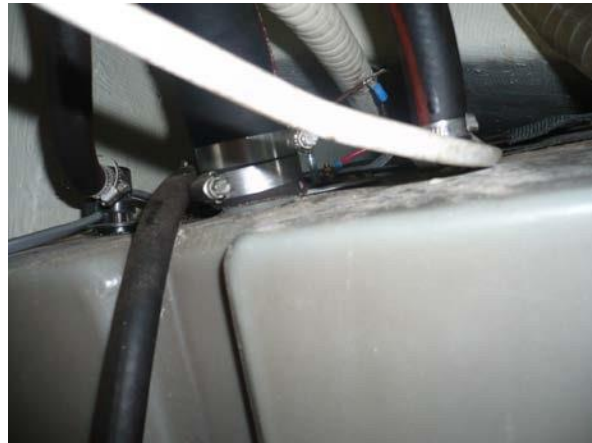
B - Found some poor electrical connections on top of the fuel tank, should be repaired.

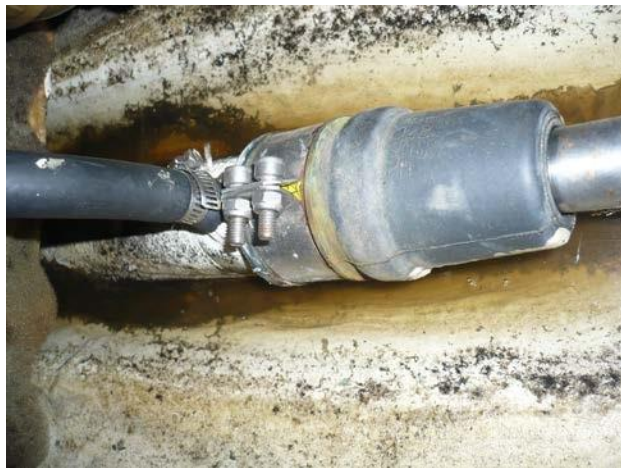
B. Water around and under stuffing box, should be observed for leaks at launch.

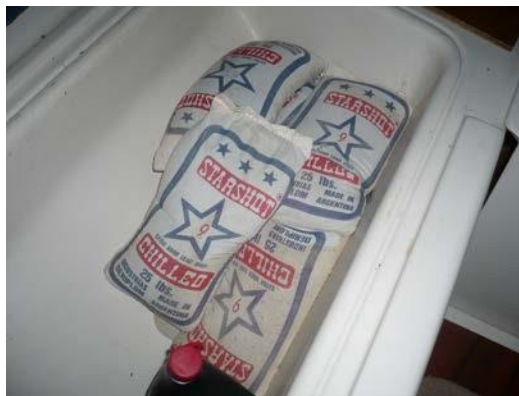
B. Several bags of lead shot found under starboard settee, not sure why.
